INTERSTATE AVIATION COMMITTEE

FINAL REPORT

ON RESULTS OF AIRCRAFT ACCIDENT INVESTIGATION

Type of an aircraft accident	Aircraft crash
Type of aircraft	Aeroplane Beech 95-B55
State and registration markings	OM-KVV
Owner	Private person
Aviation administration	CA Committee of the Republic of Armenia
Accident site	Republic of Armenia, Kotayk marz, at a distance of 1 km south-east from Djraber settlement, coordinates: 40°20'21.70" of north latitude; 44°39'06.60" of east longitude
Date and time	1 December 2022, 13:13 p.m. local time (09:13 UTC)

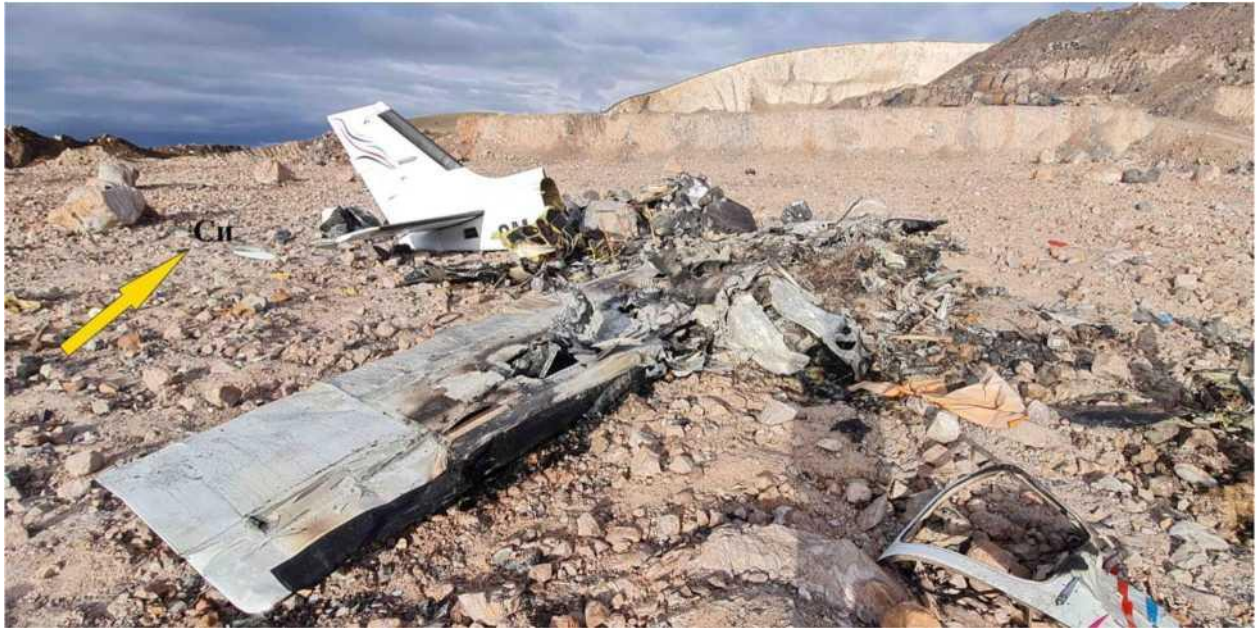
Picture 2. The overall view of an AA site

The aircraft external appearance at AA site is illustrated in Picture 2. The aircraft was completely destroyed and partially burnt.

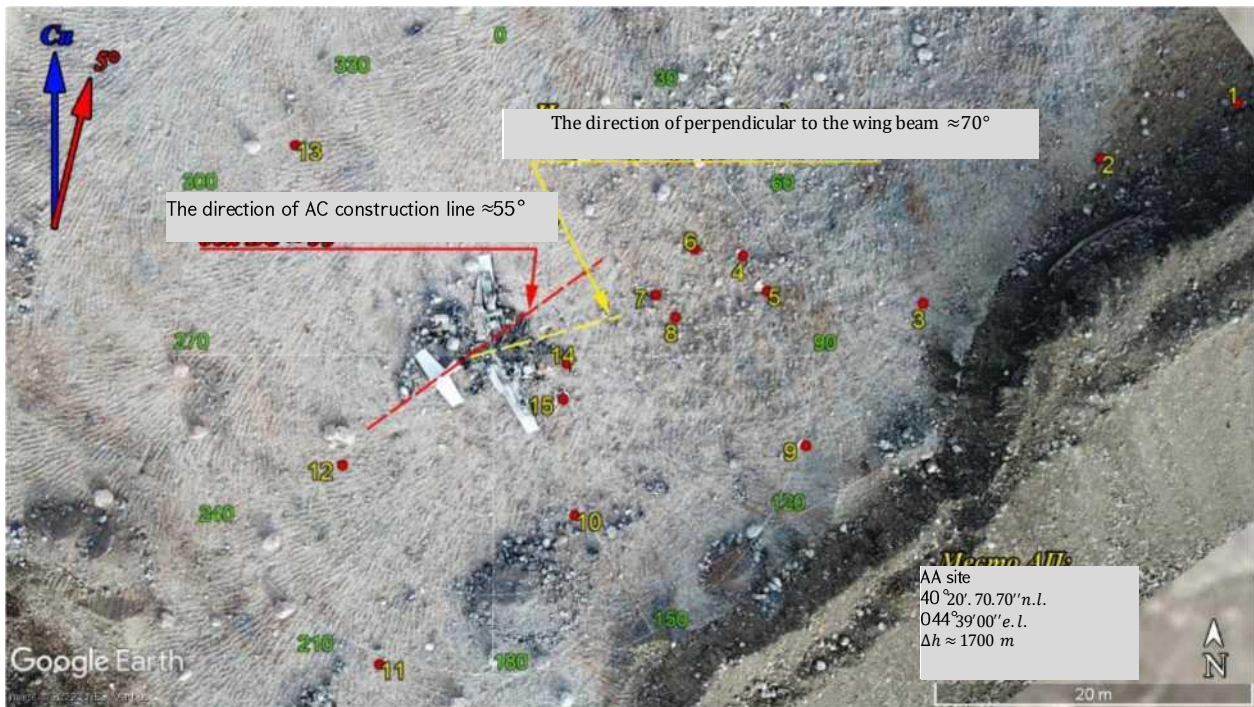
Picture 5. Sketch of AA site with Beech 95-B55 OM-KVV aircraft

The AA took place in the mountainous area in the territory of a sandpit of Kotayk marz of the Republic of Armenia. The exceedance of AA site is about 1700 m. AA site coordinates (AC cabin location on the ground surface): 40°20'21.70" north latitude; 44°39'06.60" east longitude

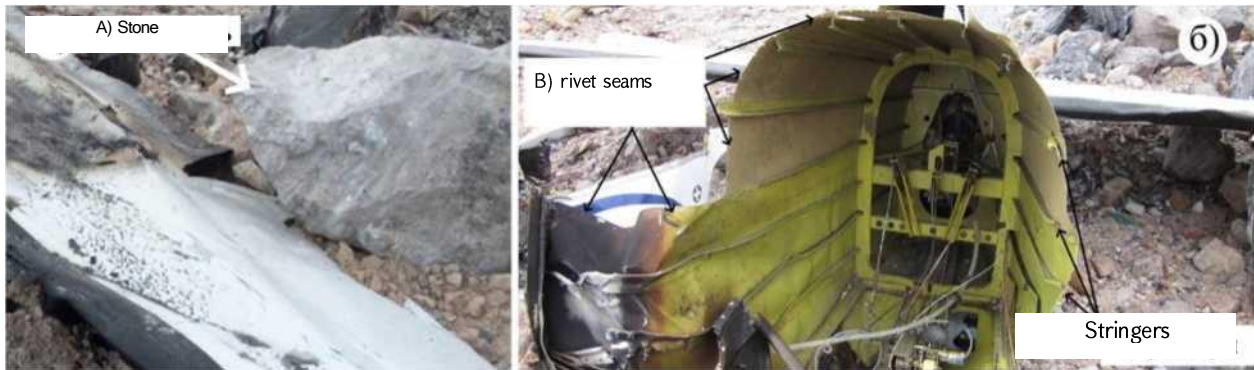
Picture 6. Image: of a stone - a), destruction and deformation of framework elements of rear end of AC – b)

Upon examination of AA site and the aeroplane components the commission drew to the conclusion that AC was approaching the ground at significant vertical speed and left turn to the aeroplane vertical axis, which is typical for left-hand spin regime.

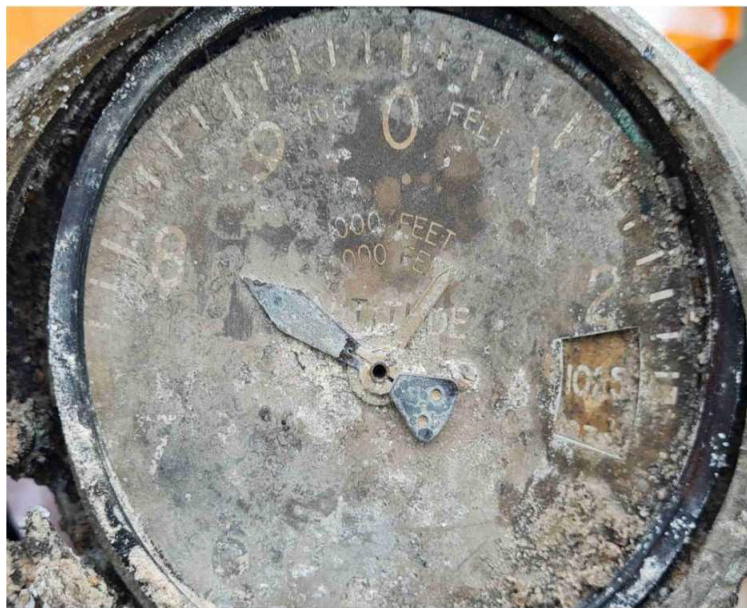
Picture 7. Image of one of pressure altitude indicators

Pressure altitude indicator (Pic. 7) is torn from the attaching point, has concussions and traces of high temperature impact. Pressure value is 1025 hPa.

²² On one of pressure altitude indicators there was a value of 1025 hPa (Picture 7). Moreover, the QNH value was 1026 hPa.

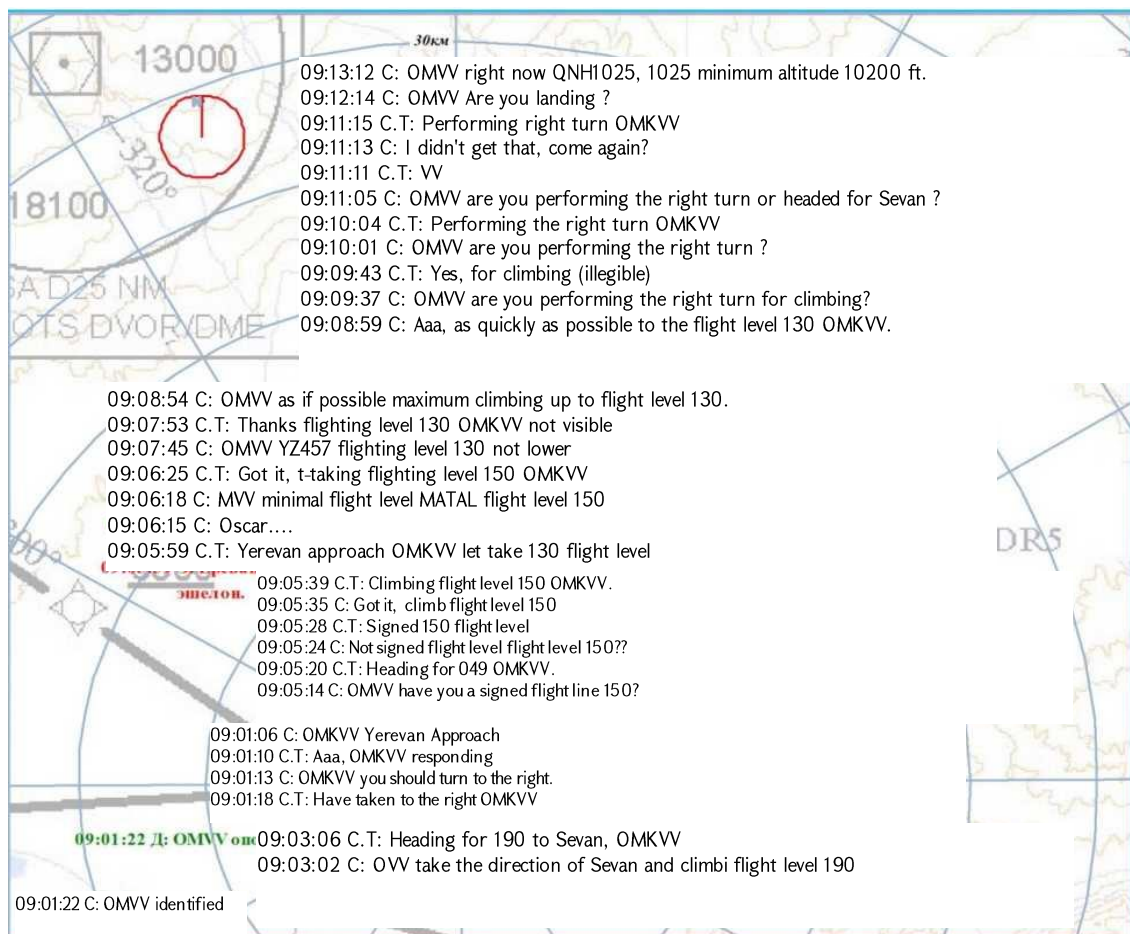
After the take-off, moving upwards, AC started deviating left from the Standard Instrument Departure SID SEVAN 3E (Picture 14), whereto the air traffic controller of Yerevan-Approach at 09:01:06 noticing the crew team: «OMKVV, Yerevan-Approach».

Picture 14. Aeroplane flight trajectory combined with standard arrival route of departure from the region of Zvartnots Aerodrome SID SEVAN 3E and radio transmissions "air traffic controller-crew team"

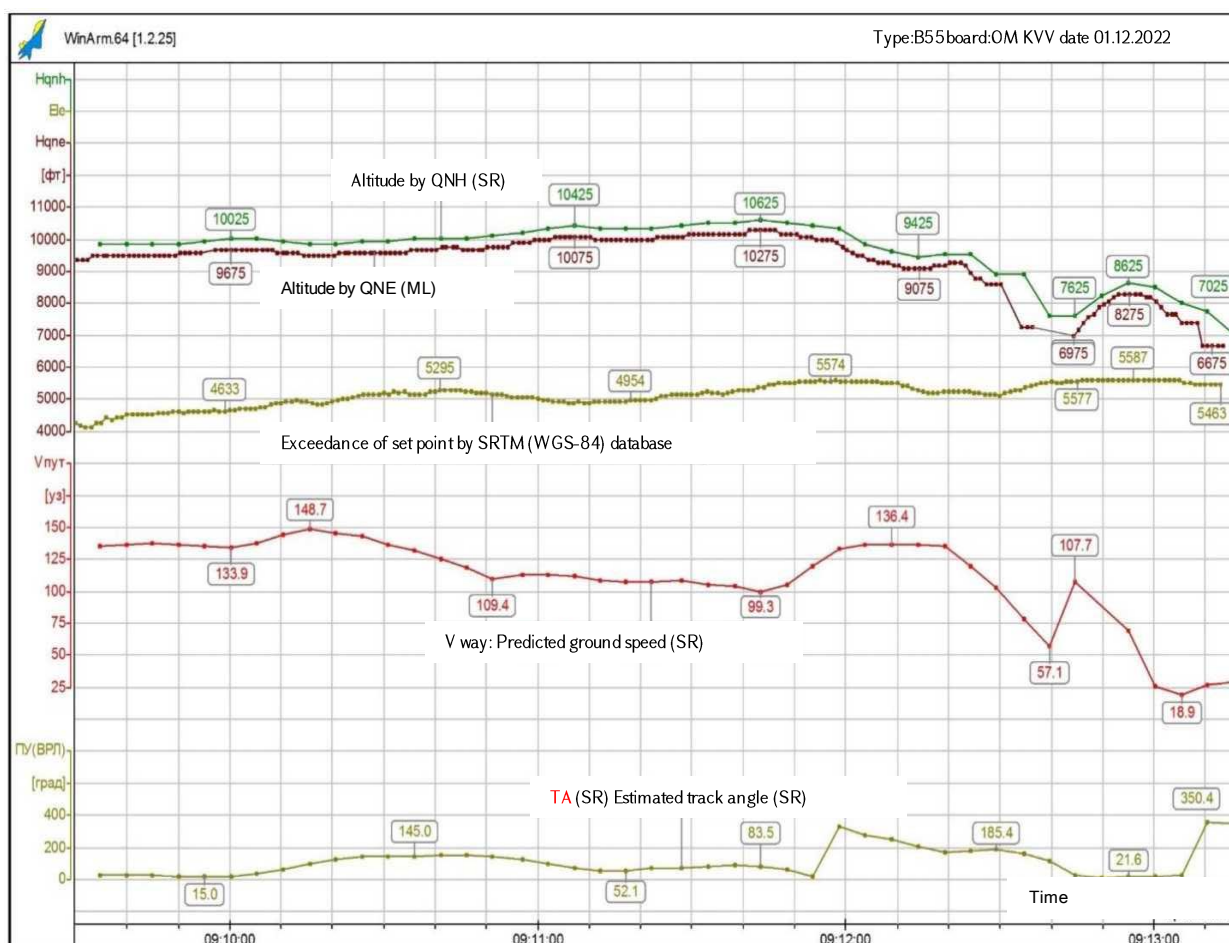
The crew team started the fulfilment of air traffic controller's instruction in 20 seconds at 09:10:01³⁰, after reminding the air traffic controller «OMVV, are you performing the right turn?», whereto the crew gave an affirmative answer: "Performing the right turn, OMKVV".

Picture 15. The parameters of aeroplane flight in the interval 09:09:30 – 09:13:16 (before the collision of AC with the ground surface)

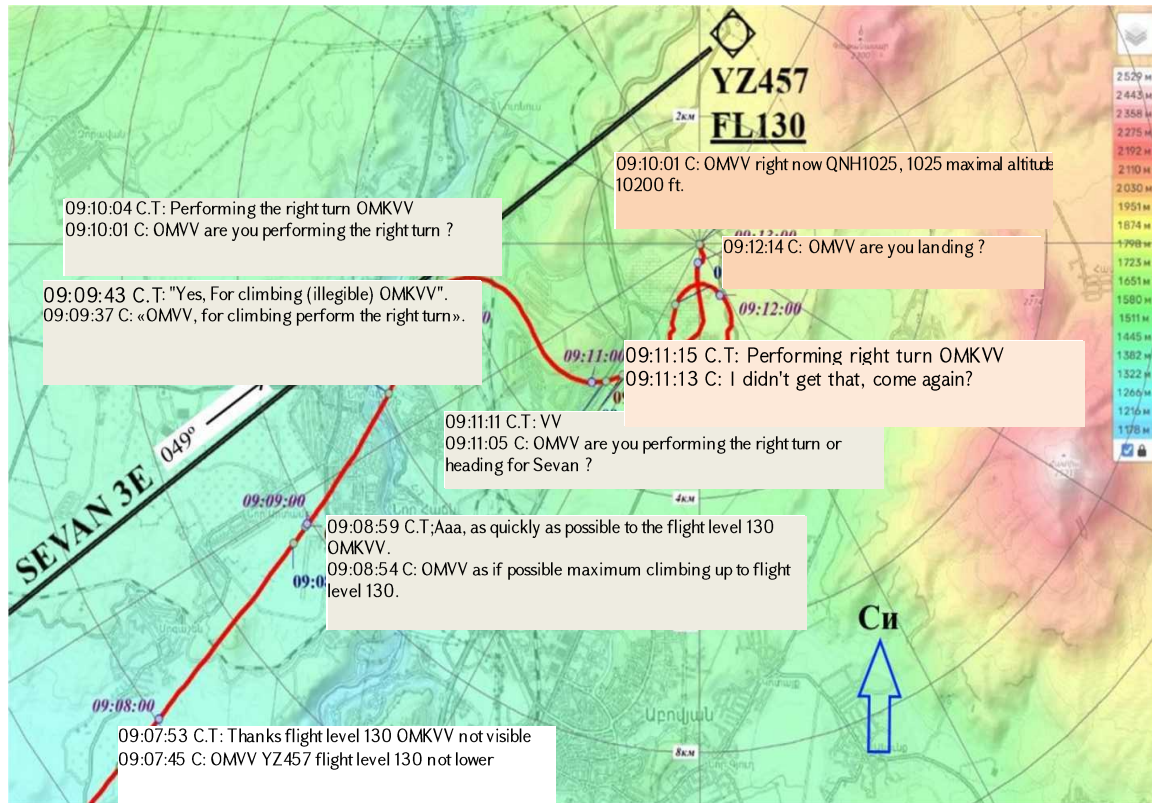
Pic. 16 The aeroplane flight trajectory in the final region combined with the standard route of departure from aerodrome's region, with topographic map and radio transmissions

By turning to the right at an angle about 130° , at 09:10:50 the crew turned AC to the left turn.

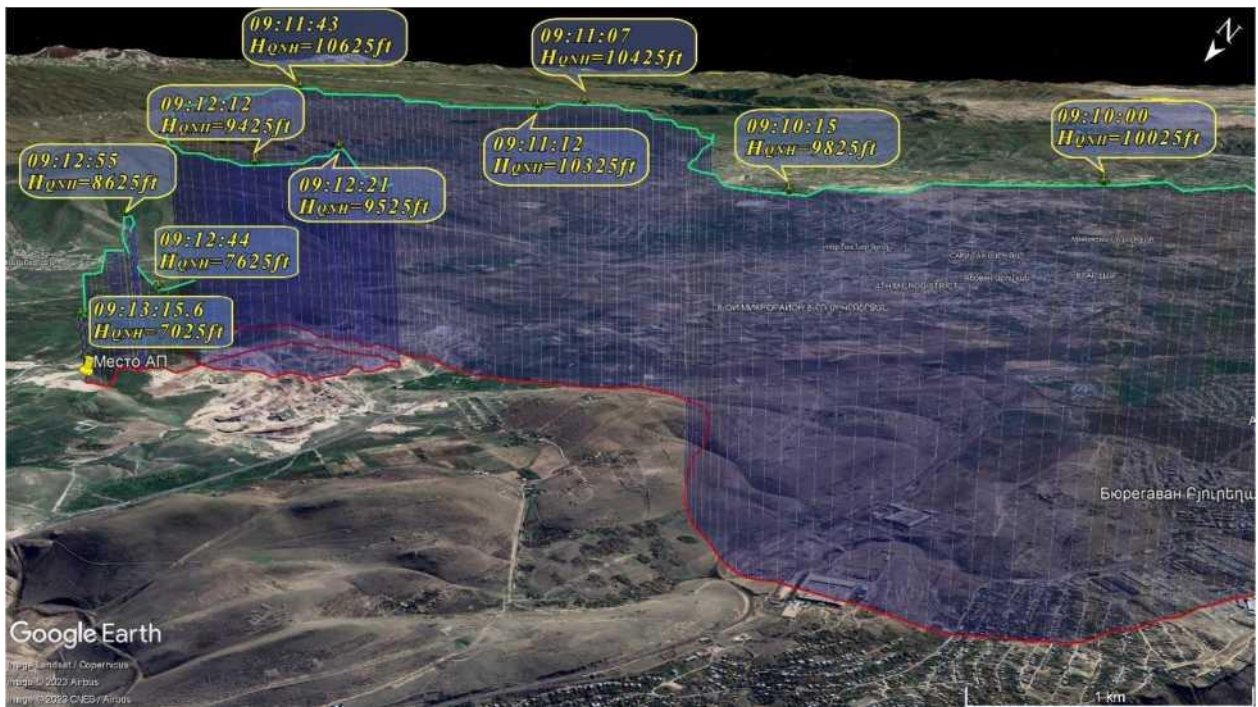
Moreover in the course of about two final minutes of flight significant altitude variations were registered (within 1000 ft or 305 m) and speed (50 kt or 92 km/h). AC switched from climbing to descending and back (Picture 17), as well as AC banking angle was also changed, though the crew team confirmed to the air traffic controller the right turn performance. From the AA investigation experience it is known that such flight parameters changes are specific to spatial disorientation by crew team.

Picture 17. Aircraft flight trajectory on the terminal subphase
